# Rainfall-related impacts on a terraced landscape: Sóller valley (Mallorca, Spain) December 2016-January 2017

*Dry-stone terraces,  
Heavy rainfall,  
Rock fall,  
Erosion,  
Mediterranean basin*

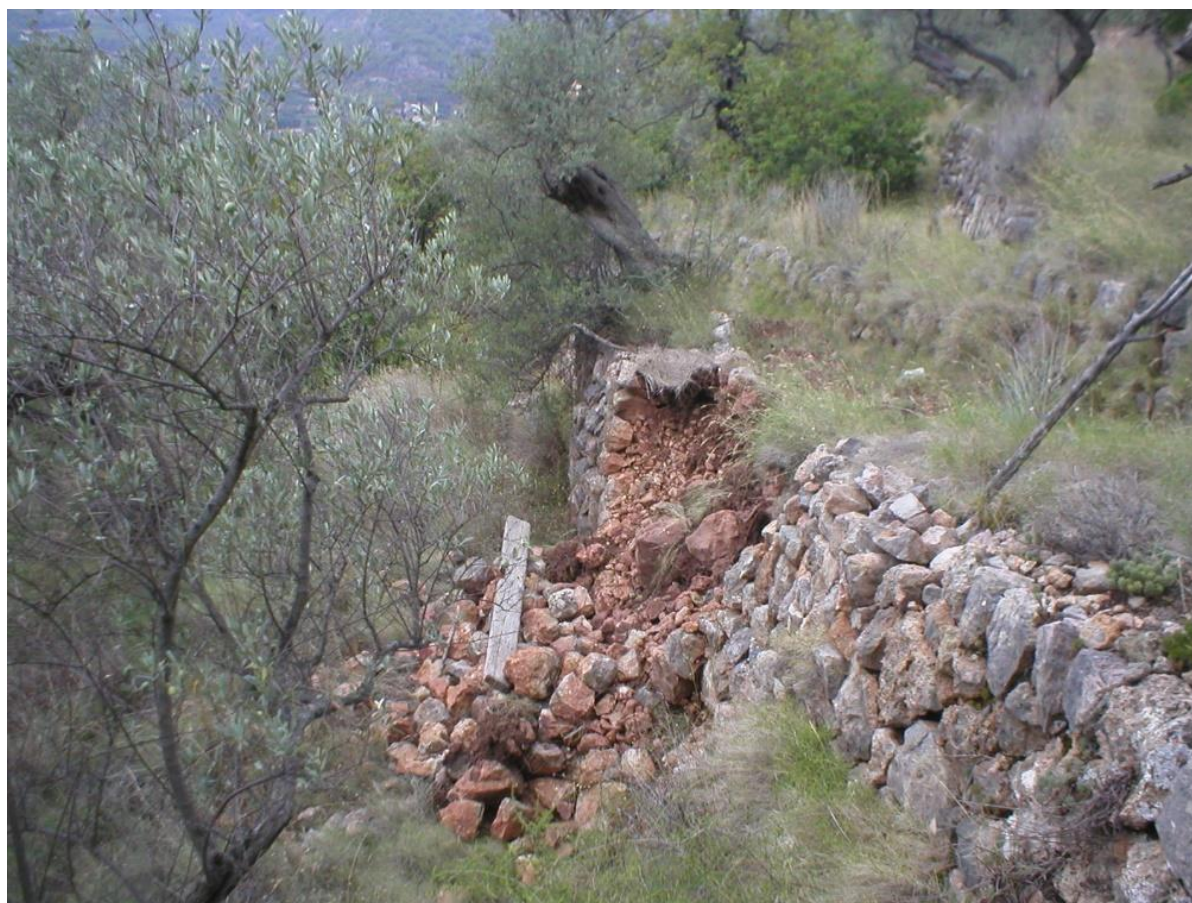
**Figure 7.** Collapsed wall in *Ca'n Costurer* plot.

In the *Ca'n Costurer* area, where the rain was supposed to be lower than in the other areas as is closer to the coast, the rainfall caused the fall of walls located underneath the one affected by the 2016 storm.

Runoff and sediments overcame the water regulation system of the preserved walls while in abandoned zones, as *ca'n Costurer*, the raindrops exposed the bedrock dragging away the topsoil. In the plots number one and five, where is still an agricultural use of the terraces, the walls impacted by the 2016 event were reconstructed or were in the process of being rebuilt, so the January 2017 rain caused only the falling of stones from the terrace top layer and the movement of rocks still laying on the terrace's soil.

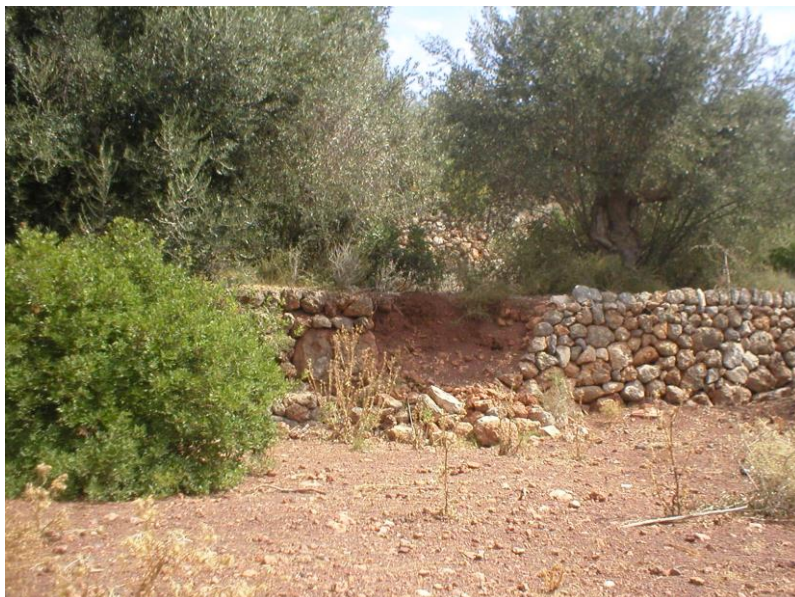
**Figure 8.** Wall collapsed (*Son Blanco*). Example of *spoon hit* collapse.

When a wall fell, the usual breaking pattern is called *golpe de cuchara* (spoon hit) (Figure 8). The wall breaks in the middle while the sides can remain standing. In the abandoned plots, the presence of scrub and trees helps the destruction of the walls as the roots grow between the rocks and help it fall.

Amongst the impacts, it is observed that raindrops felling on the soil located in the superior part of the *marge* detach the topsoil layer, thus creating small channels, which drive runoff to the wall. The amount of soil plugs the wall drains, causing it to collapse.

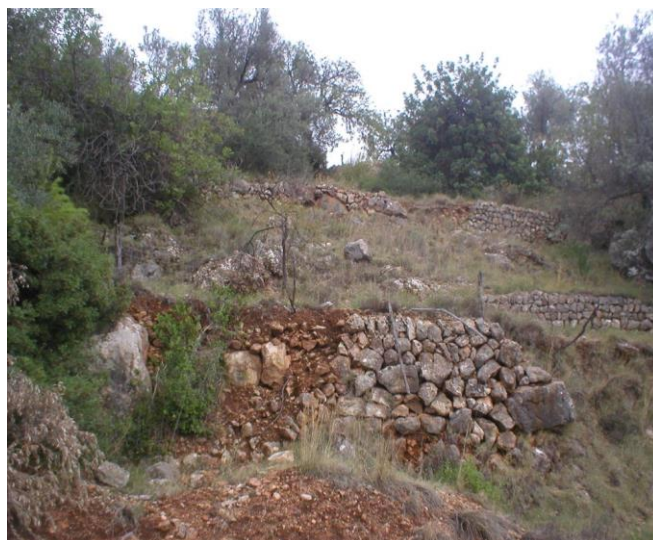
**Figure 9.** Domino's effect example. *Ses Argiles* plot.

The wall collapse starts another process, called *domino effect* (Ramón, 1997). The domino effect consists in the collapse of the walls of the terraces located downwards from the first collapsed wall as the overland flow run through the open space and concentrate in the same spot in the inferior terrace wall (Figure 9).

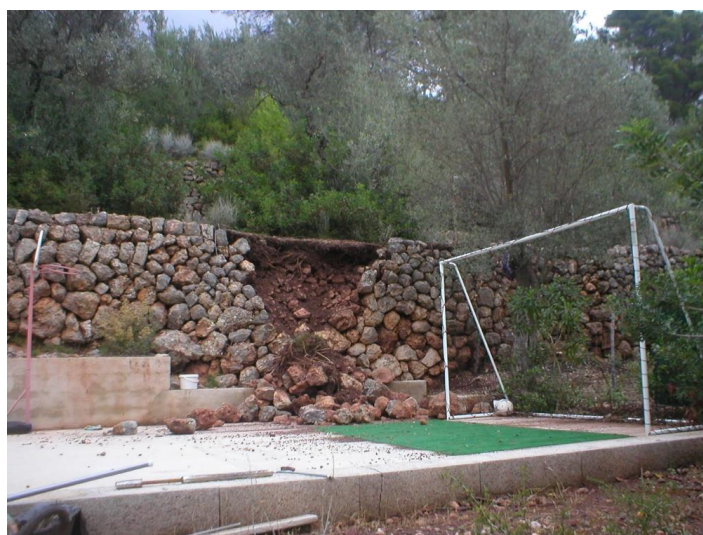
**Figure 10.** Damages of falling walls on outdoor activities.

A final important point is the risk of collapsing walls for the population. The increase of outdoor activities, like trekking, lead to an intense use of roads and paths by people, unaware of the danger. Abandoned walls can increase the risk of landslides in an already prone landslide area. The failure of a proper maintenance and the erosion process break the protective effect of the terraces outlined by Grimalt and Blázquez (1992). The residential use of former farmlands has to be taken into account as well. Urban related activities, such as second residences or rural hotels, can easily be affected by HPEs events causing the collapsing of walls or the drop of rocks (Figure 10).
